NASA TM X-3412

FULL-SCALE CRASH TEST
OF A CH-47C HELICOPTER

Claude B. Castle

Langley Research Center

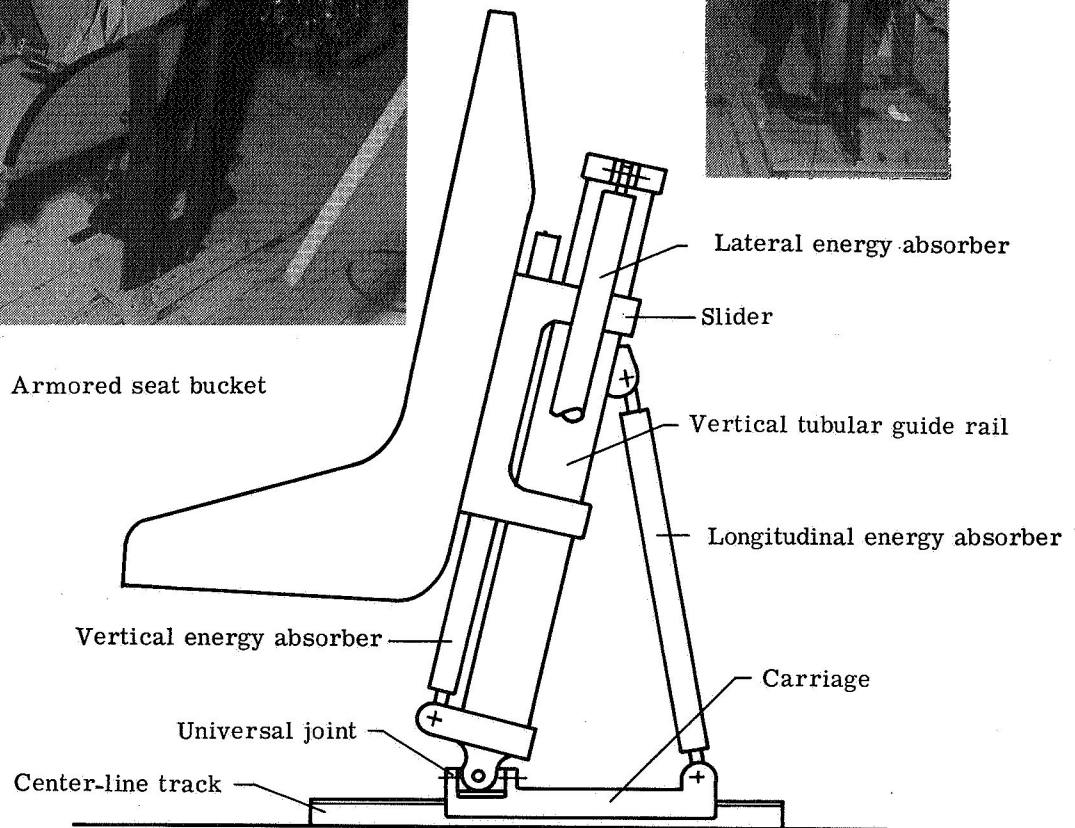
Figure 8.- Energy-absorbing crew seat in location C.

The energy-absorbing crew seat was undamaged during the simulated crash test. However, the telescoping tube torus wire-type vertical absorber failed to function during impact, and the seat did not stroke. A post-tensile test of the absorber revealed that the load required for stroking was, in reality, over two times the preset stroking load. Because of the open-ended tubes, the torus wire-type energy absorbers were susceptible to contamination by environmental factors. In the newer torus wire tubes, efforts have been made to remedy this environmental hazard by coating the inner wall of the tube, by surrounding the wire roller in a viscous fluid, and by sealing the ends of the tube.

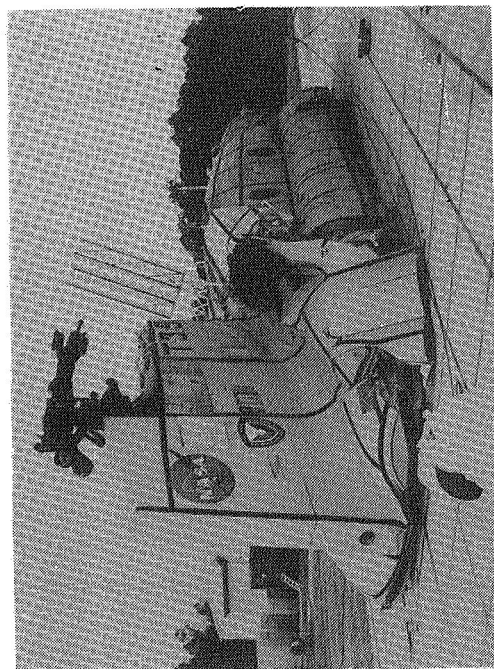
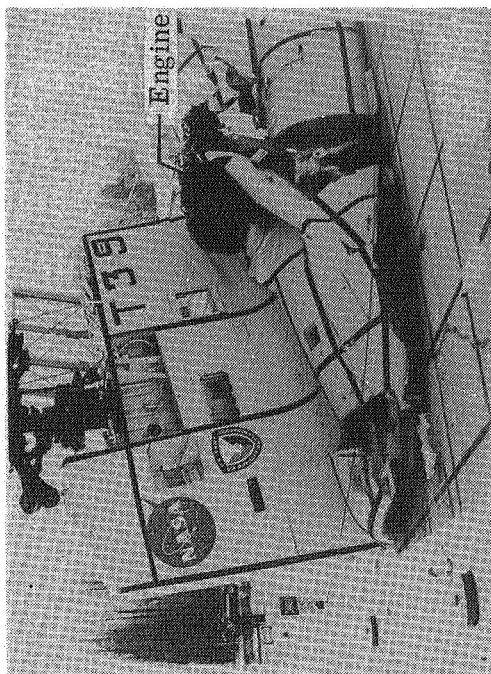
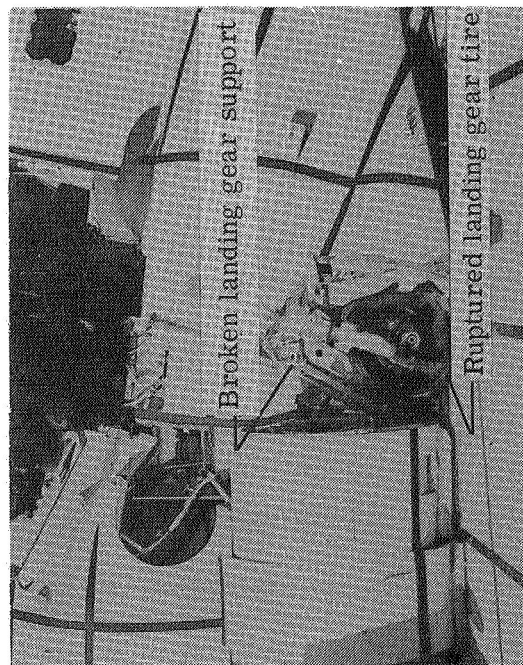
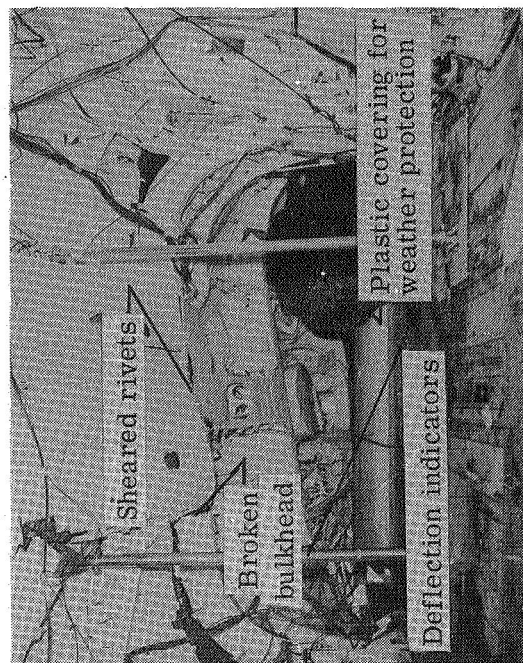
Figure 16.- Effects of high mass concentrations in impact situations.

The starboard aft landing gear made the first contact with the impact surface. A slight roll was caused by the increased mass on the starboard side as shown by the mass distribution in figure 6. As impact progressed, the aft pylon crushed the aft cabin section and intruded into the aft cabin section approximately 1 m (3.3 ft), as indicated in figure 16. In addition, the relative upward movement of the rear cabin floor in response to the rigid impact surface, coupled with the downward movement of the pylon section, completely closed the aft end of the helicopter (fig. 16(a)). The asymmetrical crushing and starboard list of the vertical sections indicate again the effect of roll and mass asymmetry. Figures 16(b) and 16(c) are closeup photographs of the section at the starboard side and the port side aft landing gear, respectively. It is evident that the impact caused both rear landing-gear tires to rupture and the landing-gear support structure to collapse. The cabin section (fig. 17) was torn by both engines, and these large concentrated masses produced a shearing failure of the aft section of the helicopter. The interior view of the cabin section, looking aft (fig. 16(d)), also indicates the combined effect of a roll attitude and the upward and downward forces applied during impact. The two posts shown are deflection indicators and did not contribute to the structural support of the helicopter: the posts indicated a closure of approximately 0.75 m (29.5 in.) on the starboard side and 0.48 m (18.75 in.) on the port side. The helicopter continued to pitch downward during impact, and the effects of the forward landing gear on the forward cabin section are shown in figure 18. The forward landing gear maintained its integrity (figs. 18(a) and 18(b)) and acted as a fulcrum for the fuselage; this condition caused the floor of the cabin section to be pushed upward as the nose made contact. The relative upward movement of the cabin floor section in the vicinity of the landing gear was approximately 0.68 m (2 ft). An

(a) View from rear.

(b) View from starboard side.

(c) View from port side.

(d) View from inside looking aft.
L-76-270

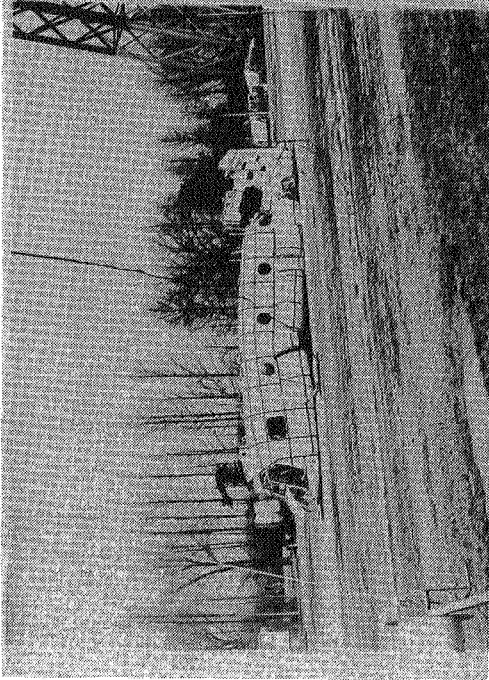
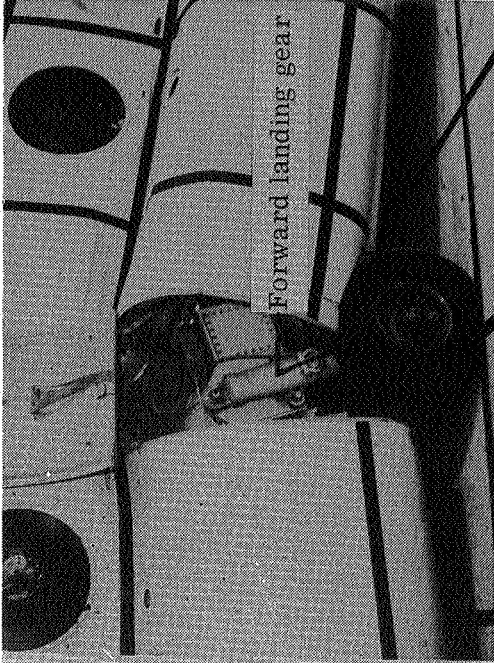
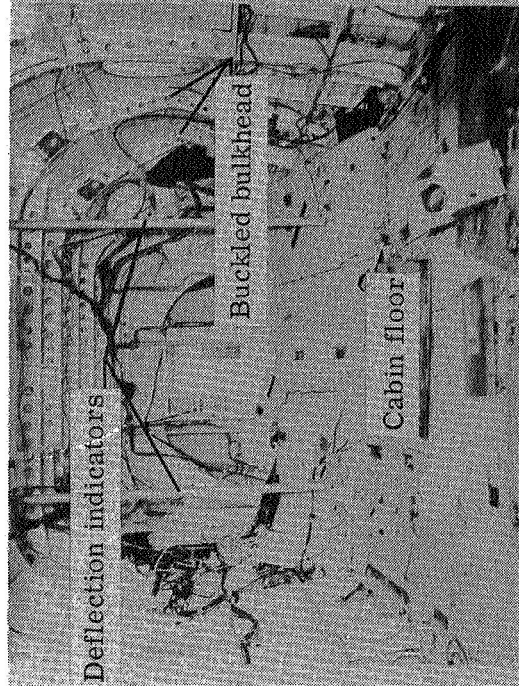
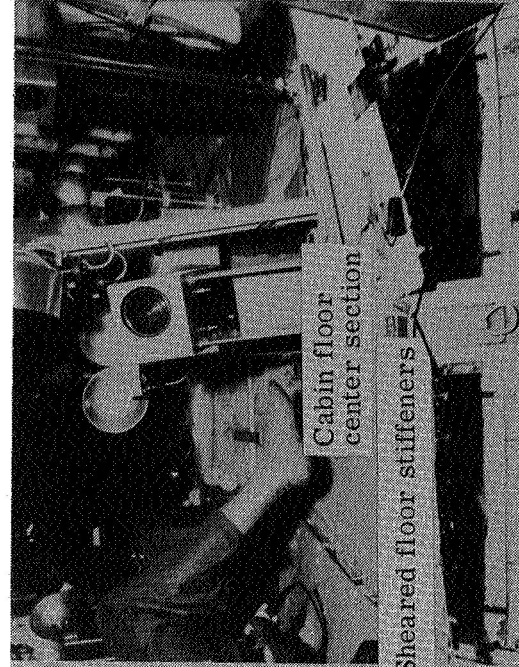
Figure 18.- Effect of forward landing gear after impact.

interior view of this area looking forward in the cabin section is shown in figure 18(c). Again, the two posts shown are deflection indicators and are not a part of the support structure. The posts recorded a closure of the fuselage of approximately 0.23 m (9 in.) on both the starboard and the port side. A view of the same area looking aft (fig. 18(d)) shows the shear separation of the stiffened center floor sections. The pivoting of the nose section about the forward landing gear induced buckling of the bulkheads on both sides of the fuselage (fig. 18(c)) about midway between the floor and ceiling.

(a) View from port side.

(b) Closeup from port side.

(c) View from inside looking forward.

(d) View from inside looking aft.
L-76-272

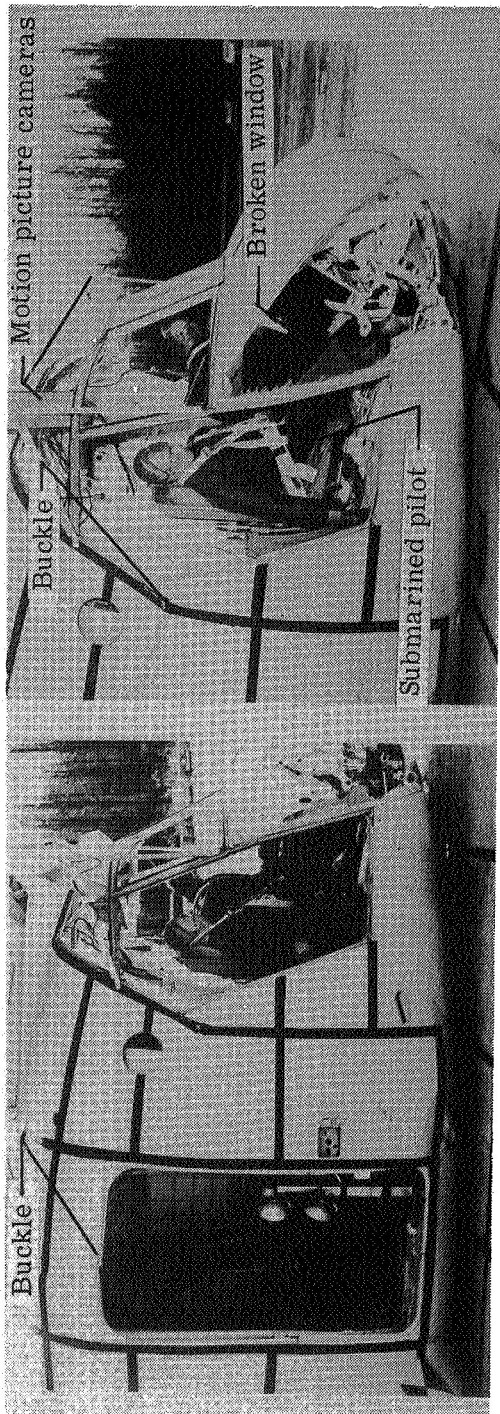
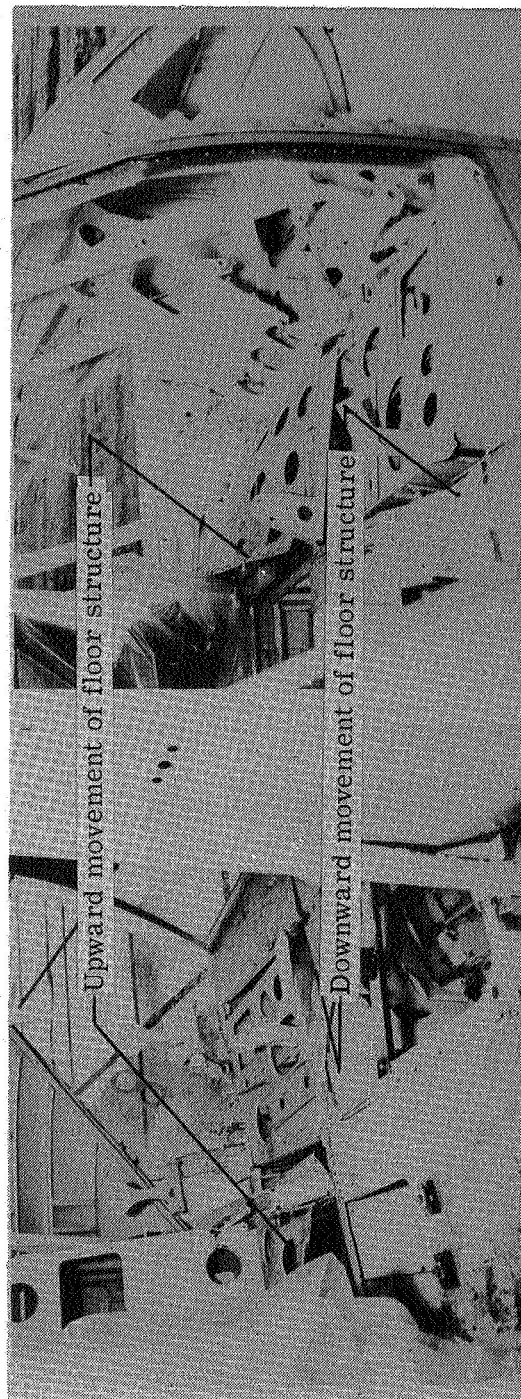
Figure 19.- Effects of crash on cockpit section.

The cockpit area shown in figure 19 was not heavily damaged and maintained its livable volume. This lack of damage can be attributed to the crash attitude, and to the large amount of energy dissipated in the crushing of the aft fuselage and in the fuselage section over the forward landing gear. In figures 19(a) and 19(b), a vertical buckle can be seen in the skin over the cabin door, and a longitudinal buckle can be seen at the midpoint of the cockpit. The windshields were removed prior to testing, but both "chin bubble" windows broke on nose contact. The pilot and copilot remained in their seats, but the pilot experienced a downward and forward movement commonly referred to as "submarining" because the pilot did not have a lap belt tiedown strap. The structural deformity (figs. 19(c) and 19(d)) of the floor section beneath the pilot and copilot indicates a clockwise twisting moment. The floor area beneath the copilot is lifted upward while the floor area under the pilot shows that a compressive downward force has been applied.

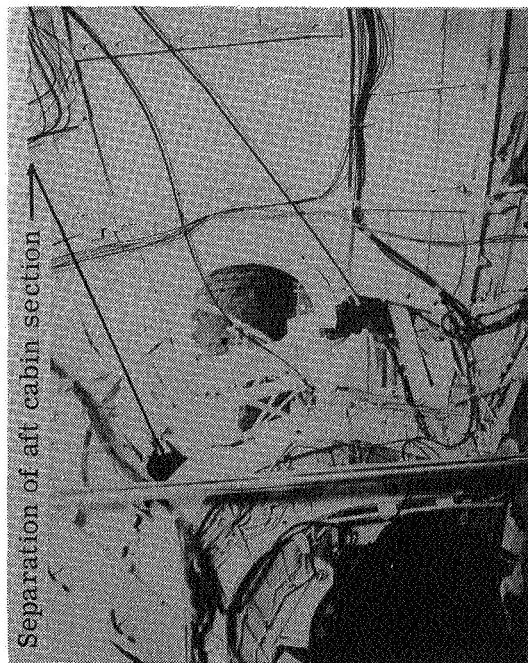
Representative photographs showing the different types of fuselage damage that occurred during the test are presented in figure 20. The shearing of rivets and the tearing of skin and bulkhead sections of the cabin section in the vicinity of the aft landing gear are shown in figures 20(a) and 20(b). (Black mass in photograph is plastic covering used for weather protection.) Other structural damage can be seen in figure 16(d), where the cabin section has separated; the bulkhead has sheared; and the ceiling plates are bent, torn, and buckled. Figure 20(c) shows the starboard side, looking aft, where the floor plates meet the cabin wall over the forward landing gear. The heavy mounting plate used to hold a bank of lights (fig. 11) remained attached to the floor; however, there was some tearing and bending of this plate due to the relative upward movement of the forward landing gear. Most of the damage in this area occurred under the floor plate and is not evident from the photograph. In spite of this floor damage, all seats remained attached to the primary structure throughout the crash sequence. Figure 20(d) is a view looking aft at the port side where the floor attaches to the sidewall. Here again, most of the major damage occurs near or below the floor area. In this photograph and in figure 18(d), the floor stiffeners are shown to have been sheared by the pivoting action about the forward landing gear.

(a) Port side aft section.

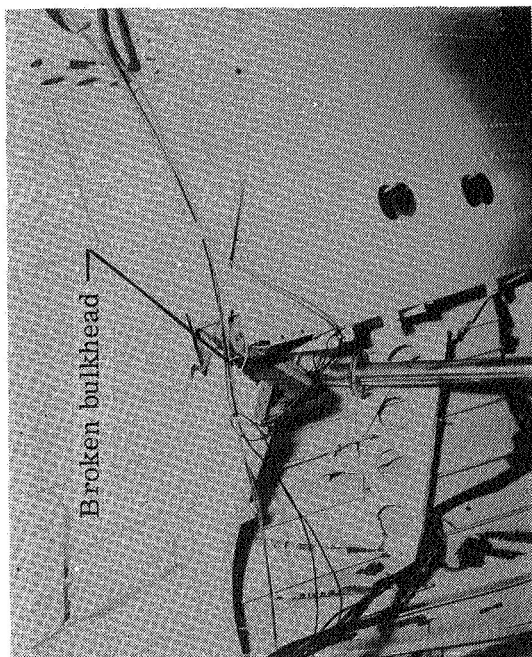
(b) Aft roof section.

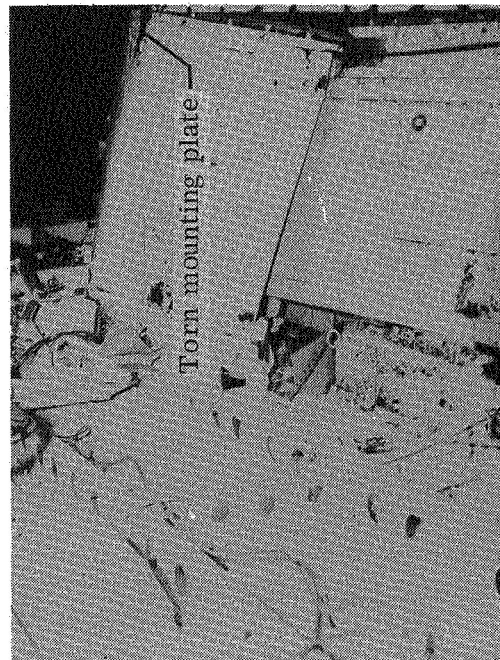
(c) Starboard side over forward landing gear.

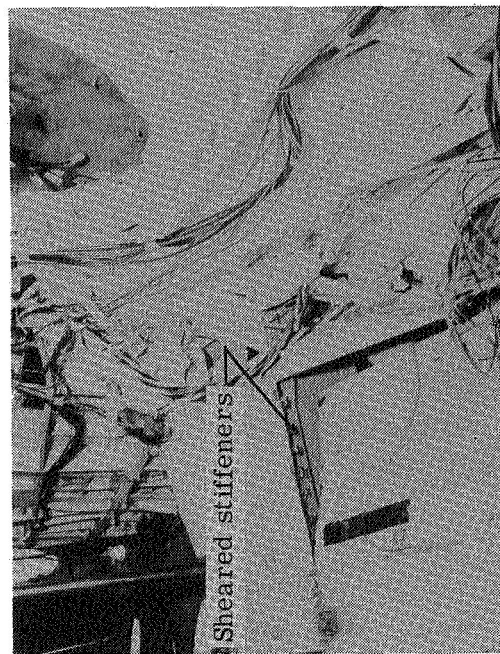
(d) Port side over forward landing gear.
L-76-274
